# Submerging vehicles

An account of descriptive and experimental research undertaken for the Minister of Social Affairs and Public Health

**Institute for Road Safety Research SWOV**

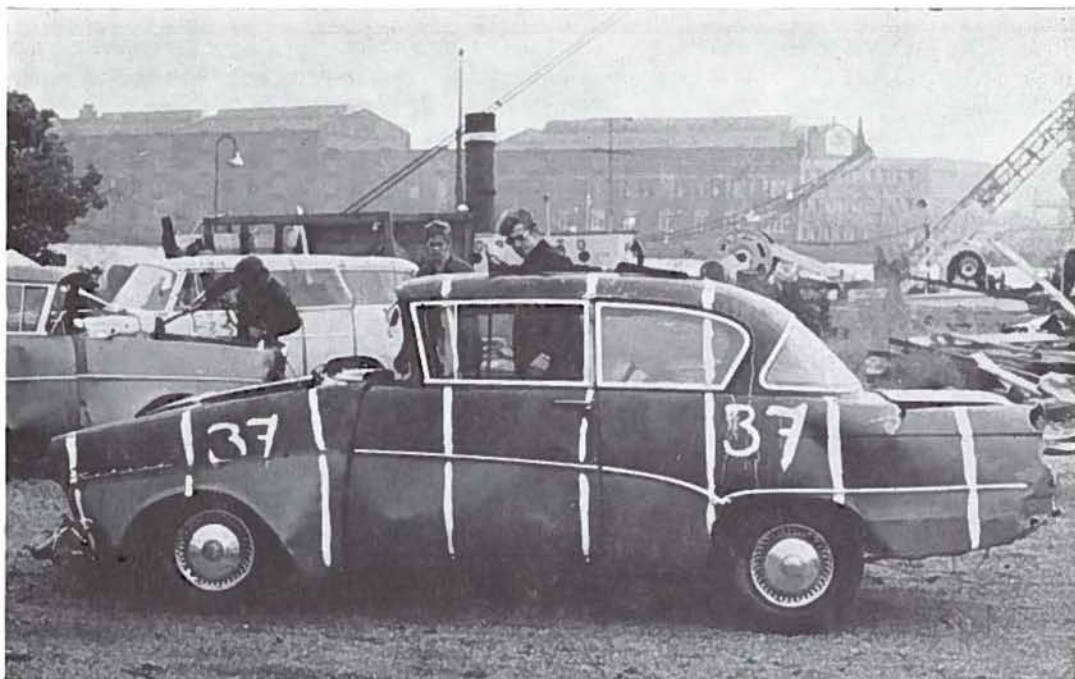
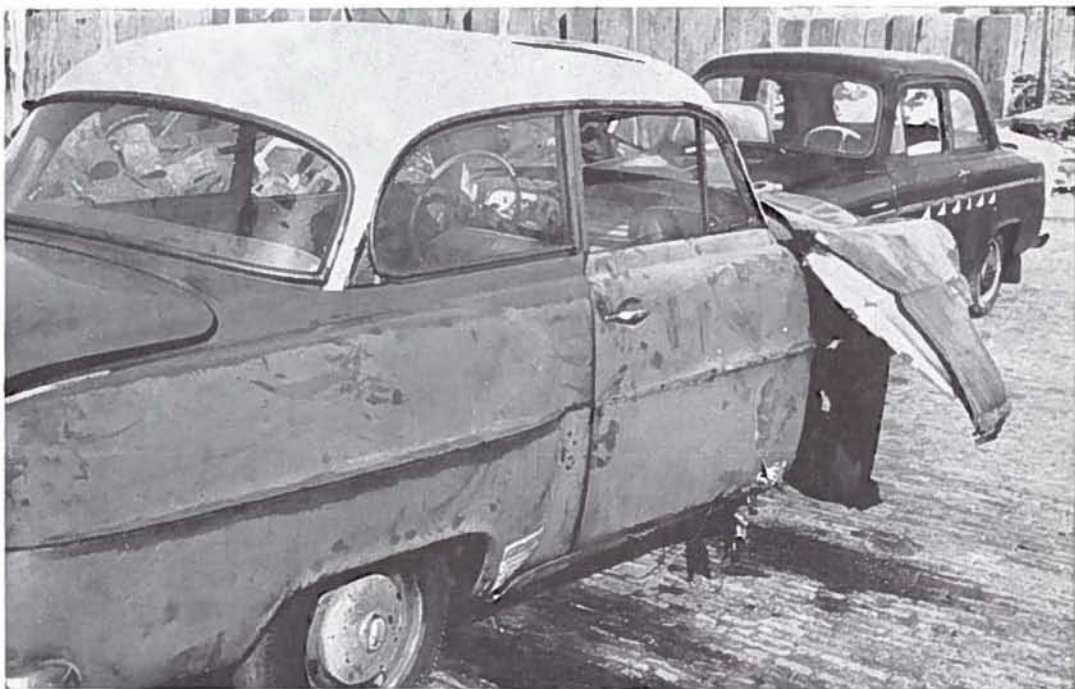
Figure 9.

Figure 8 and 9 - Bonnet and boot can be deformed, provided the cabin remains intact.

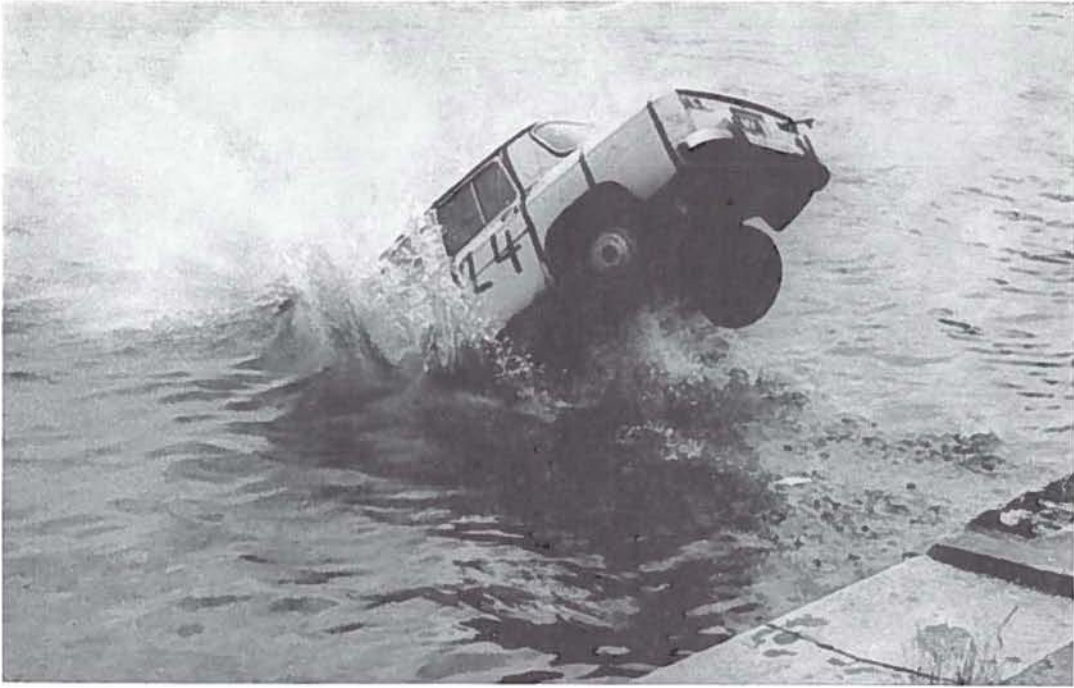
Figure 10. Even at an impact speed of about 25 km/h a deceleration of as much as 30–40 m/s<sup>2</sup> was achieved if the bank was high.

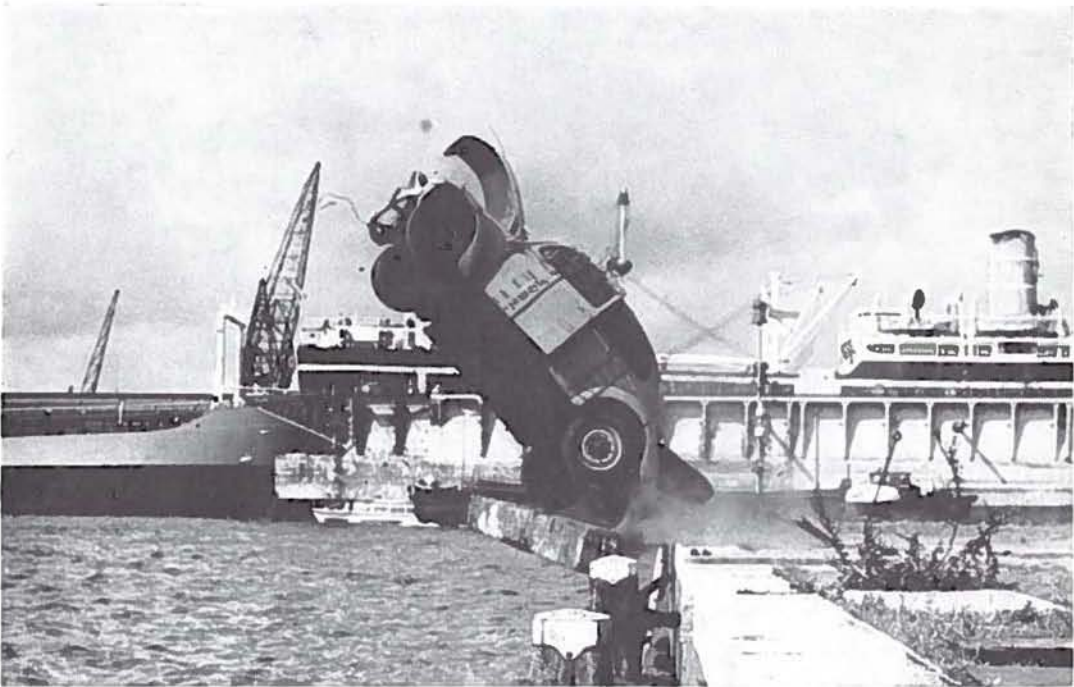
Figure 11. Often the vehicle collides with an obstacle just before crashing into the water, this may cause it to hit the water in strange positions.

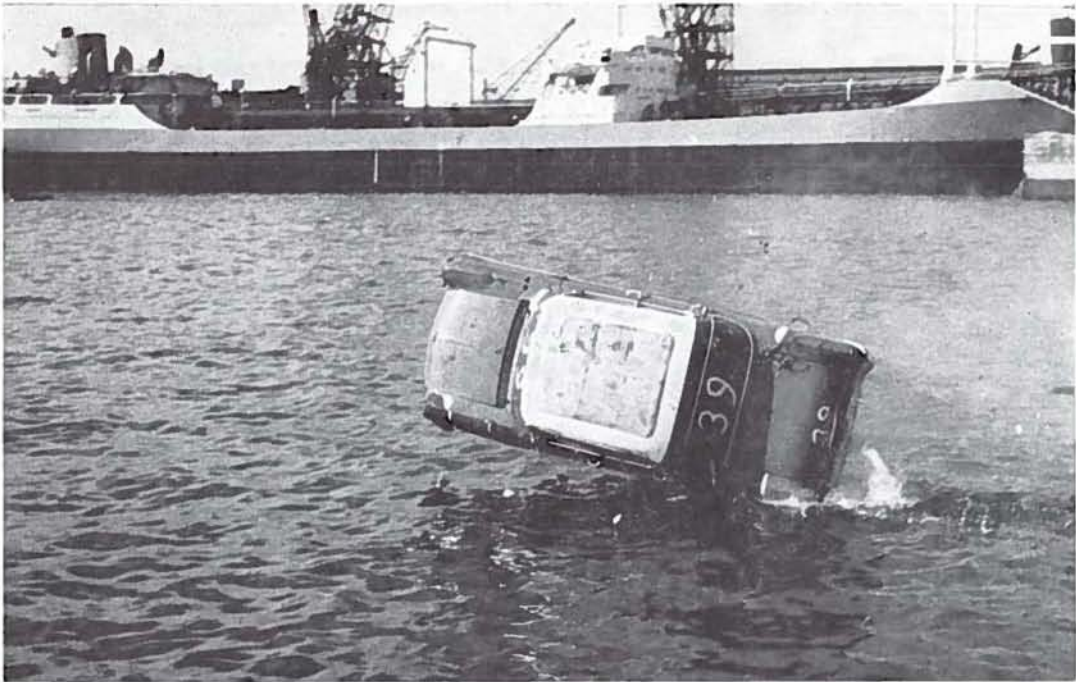
Figure 12. Not all vehicles land normally on their wheels.

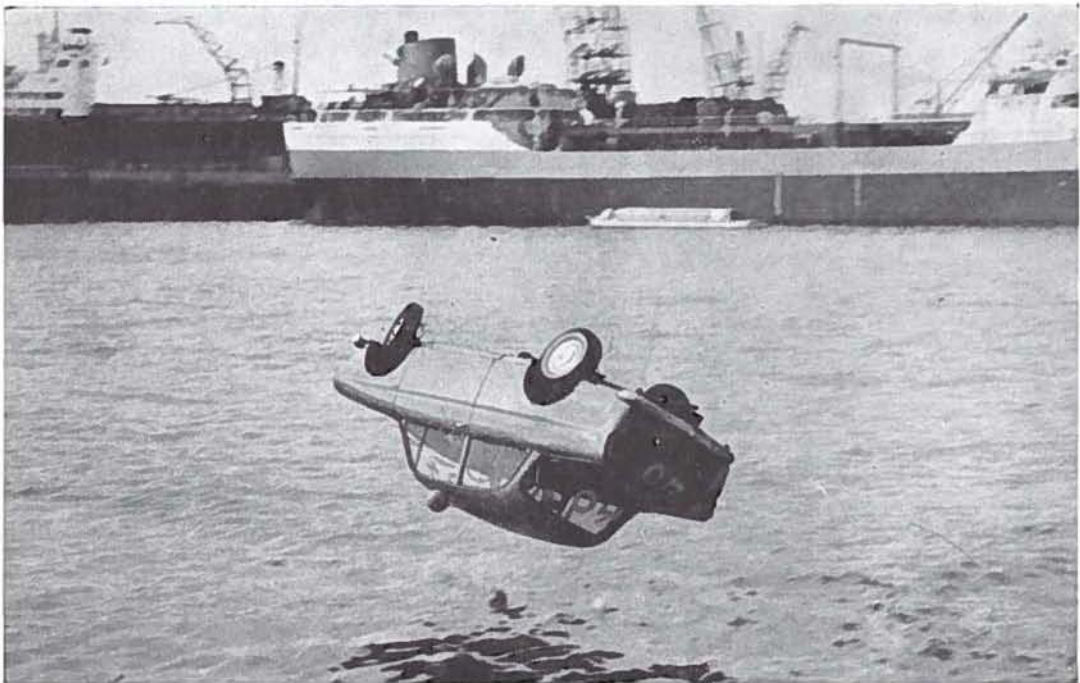
Figure 13. It is quite possible for a vehicle to hit the water on its roof, say, because of a proper skid.

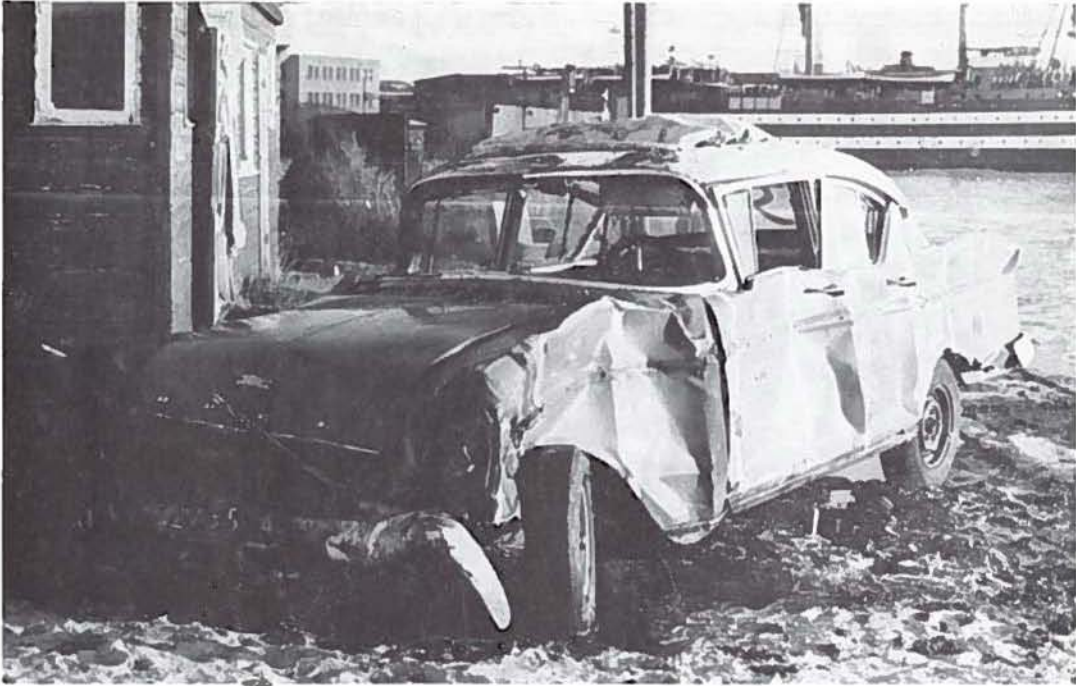
Whereas the cabins of most cars normally remain intact when they crash into the water in the normal position (i.e. horizontally with the wheels downwards), the situation is completely different if, due to certain circumstances, the vehicles hit the water on its side (Figure 12) or on its roof (Figure 13). In the first case, the side of the car can be pressed in to such an extent that the doors on that side cannot be opened (see Figure 14). In the second case the roof

Figure 14. The result of hitting the water sideways: all the doors are jammed on the impact side.

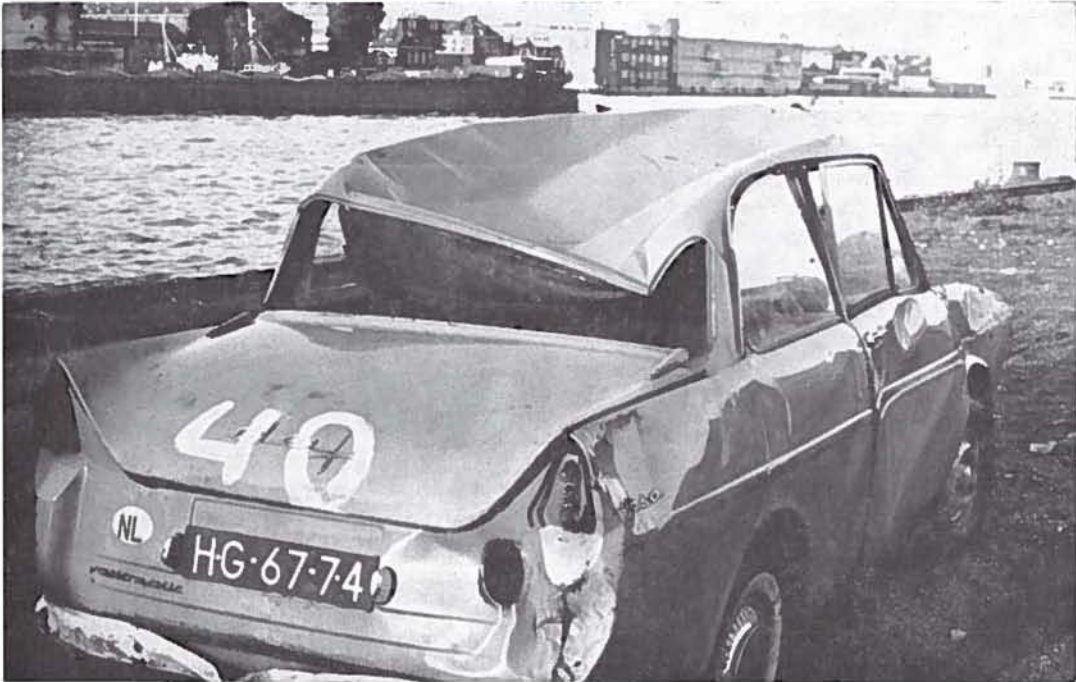
may be pushed inwards – by as much as 40 cm, as was found in one of the test vehicles (Figure 15). It was also found in the tests that if a car with a closed sliding roof landed upside down on the water this roof was often so badly damaged that it could not be opened, or only with difficulty.

Figure 15. The cabin was badly pressed in because the vehicle landed on its roof.

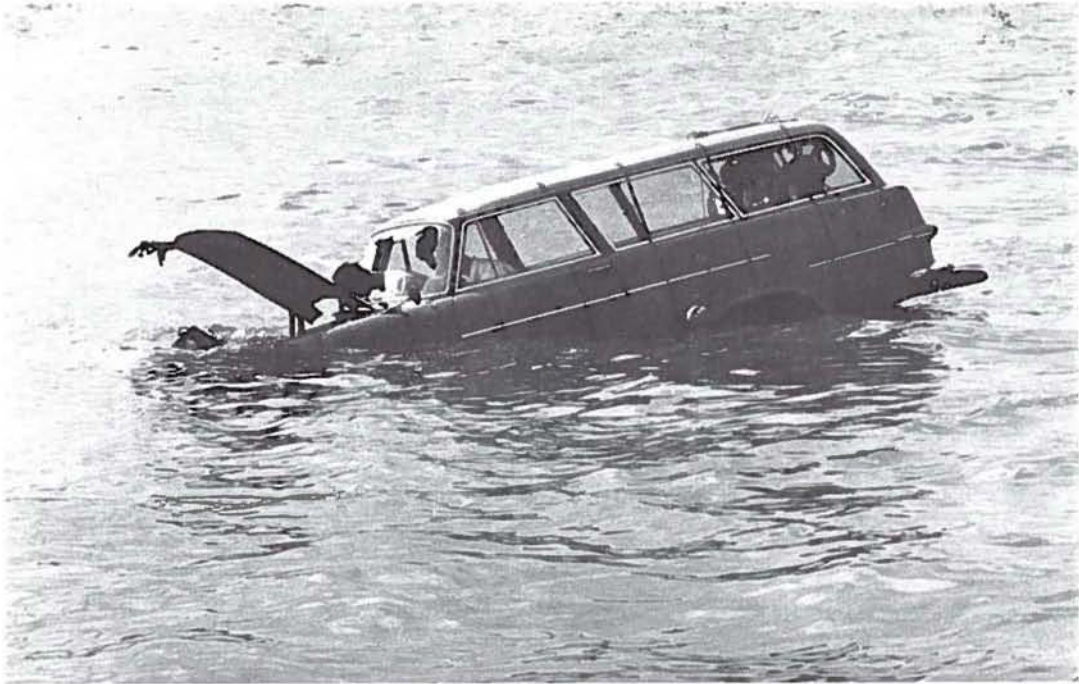
Figure 16. If the occupants are not wearing safety belts they greatly reduce their chances of survival.

Wearing safety belts will in most cases be sufficient to protect against (serious) injury. Moreover, the belts keep the occupants better in their place so that at the start of the escape phase they will be able to find their way about better and will therefore have better chances. There is much in favour of safety belts having a uniform type of fastening, which can also be undone easily when the material is wet. It must also be a fastening which is simple for others to open.

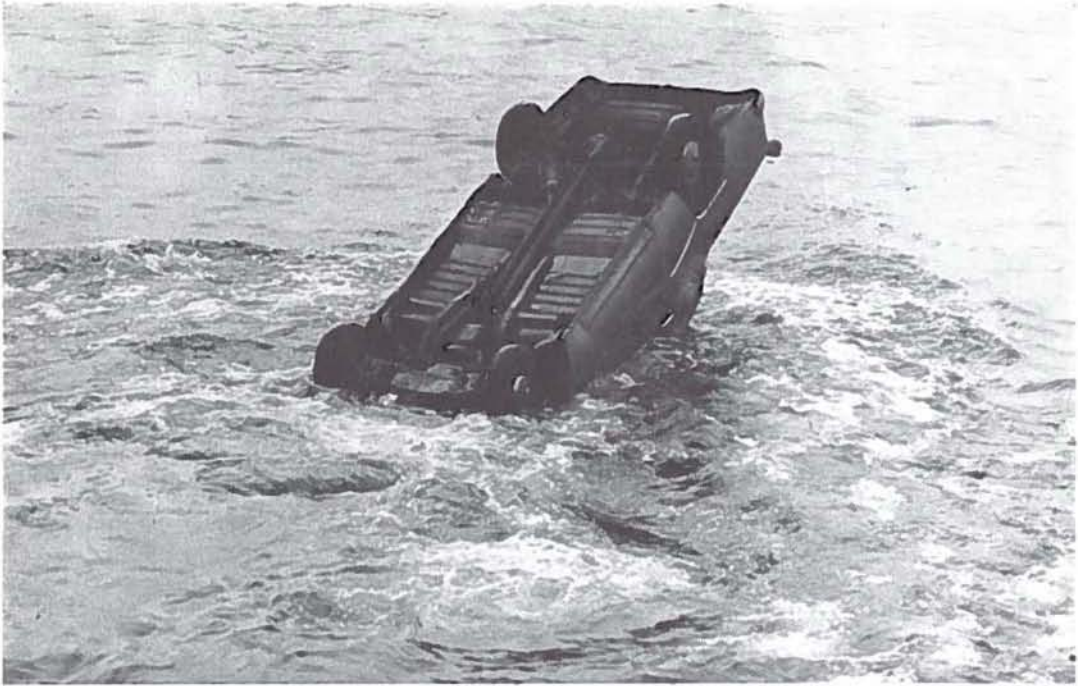
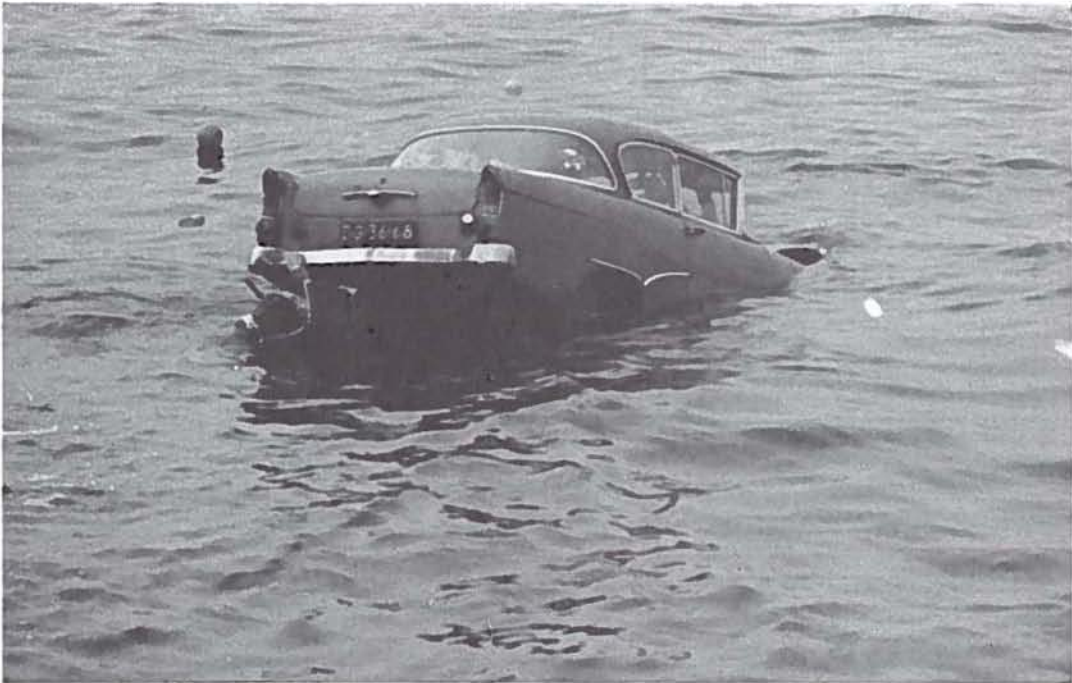
Figure 18.

Figures 17 and 18. Most vehicles which hit the water upside down return first to an almost horizontal position before they sink.

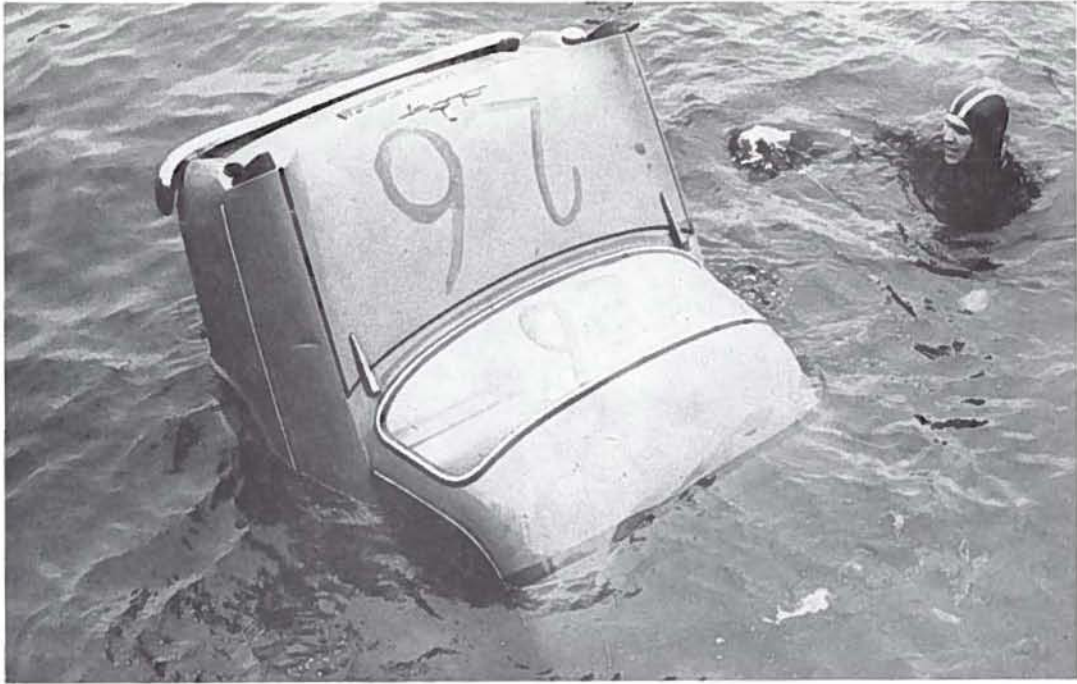
Figure 19. Cars with front engines almost always sink nose-downwards.

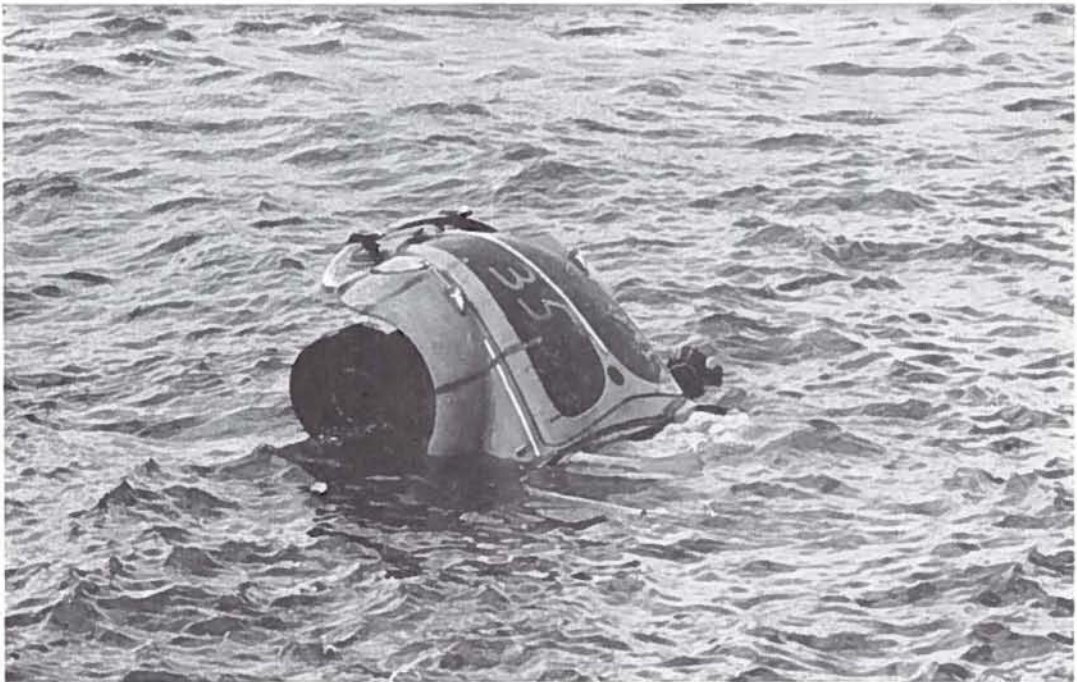
Figure 20. Rear-engined cars almost always sink tail-down.

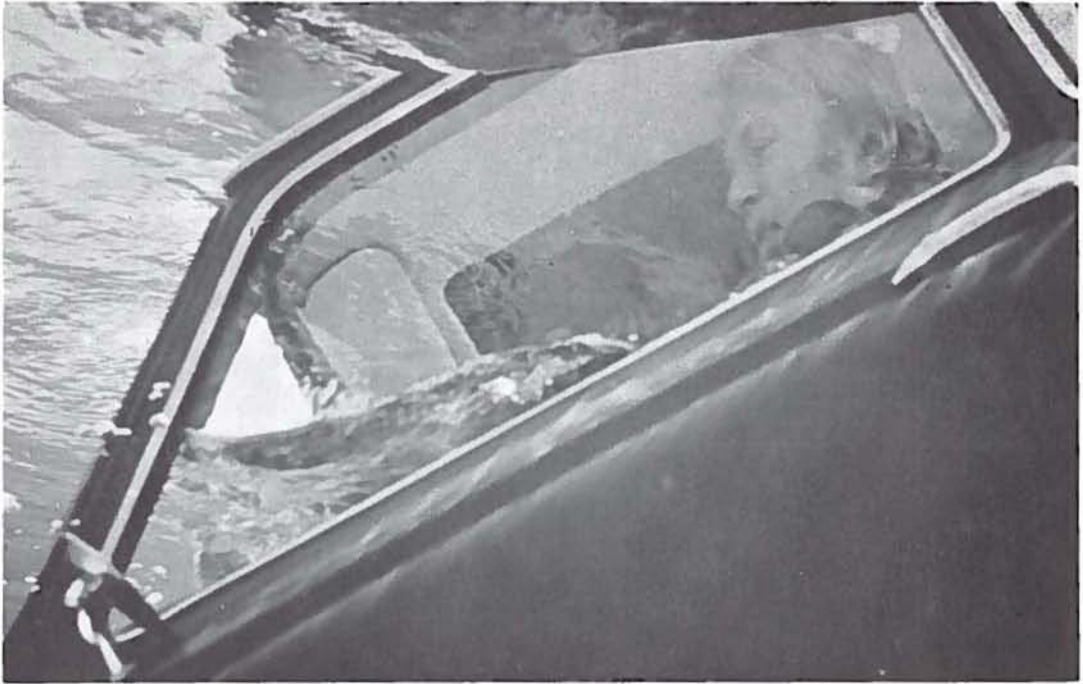
Figure 21. As the car sinks the air is forced to the highest part of the cabin so that one has a chance to fill one's lungs.

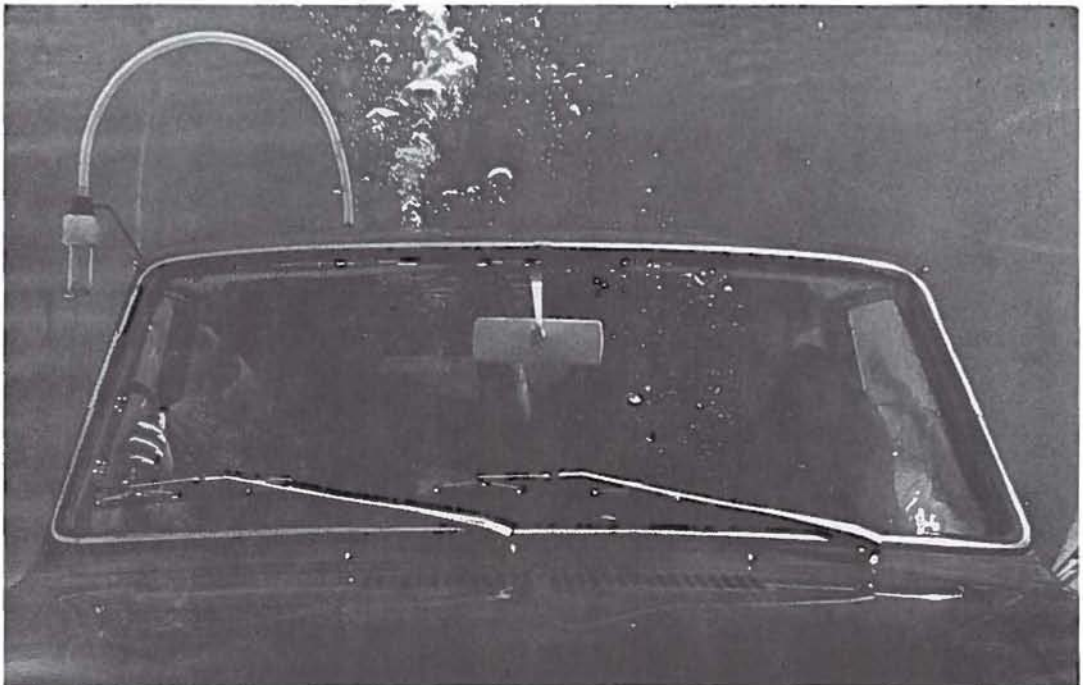
Figure 22. By the time the vehicle has come to rest on the bottom there will hardly ever be any air left in it.

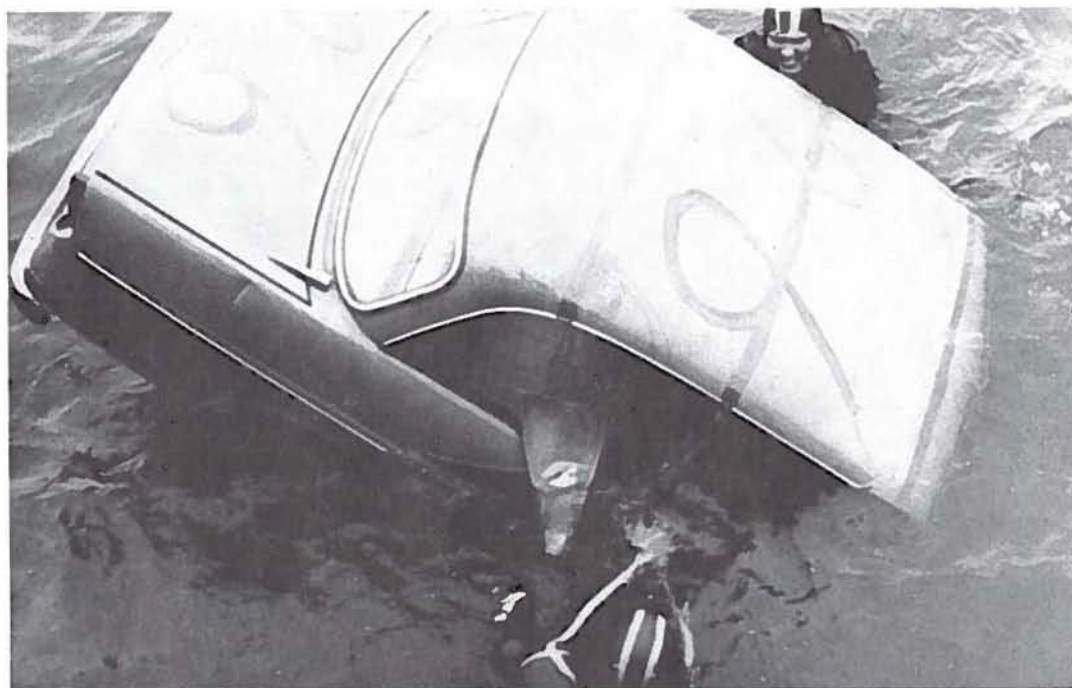
1. It is obvious that the first attempt is to leave the vehicle by opening a door. However, the pressure on the doors is usually too great for them to be opened, even when the car has only just landed in the water (Figure 25). Often, when the water level on the outside has scarcely risen to halfway up the door, there is already a force of 75–100 kgf pressing against this door. This means that an occupant would have to use a comparatively great amount of force to get this door open and this is usually impossible in view, of the difficult position the occupant would be in.

Figure 25. Fairly soon after impact with the water it is no longer possible to open the doors.

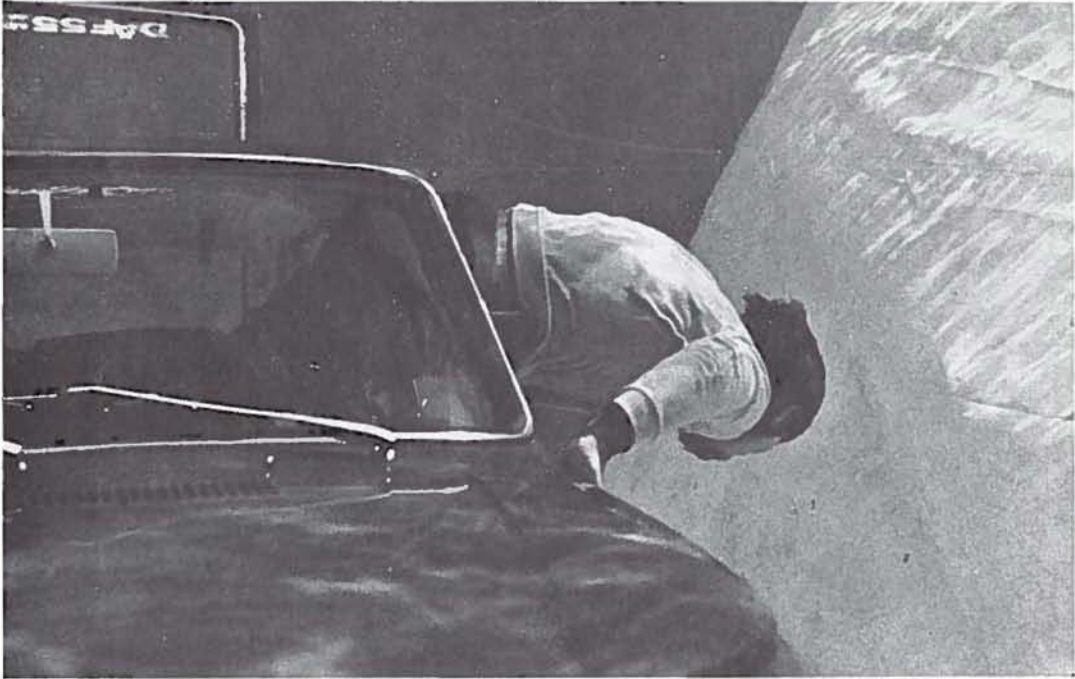
2. But not all vehicles sink in such a way that this manner of escape is possible. In such cases open windows can serve as an escape route provided they are big enough (Figure 26).

Figure 26. Escaping via an opened front window is possible both above and under water.

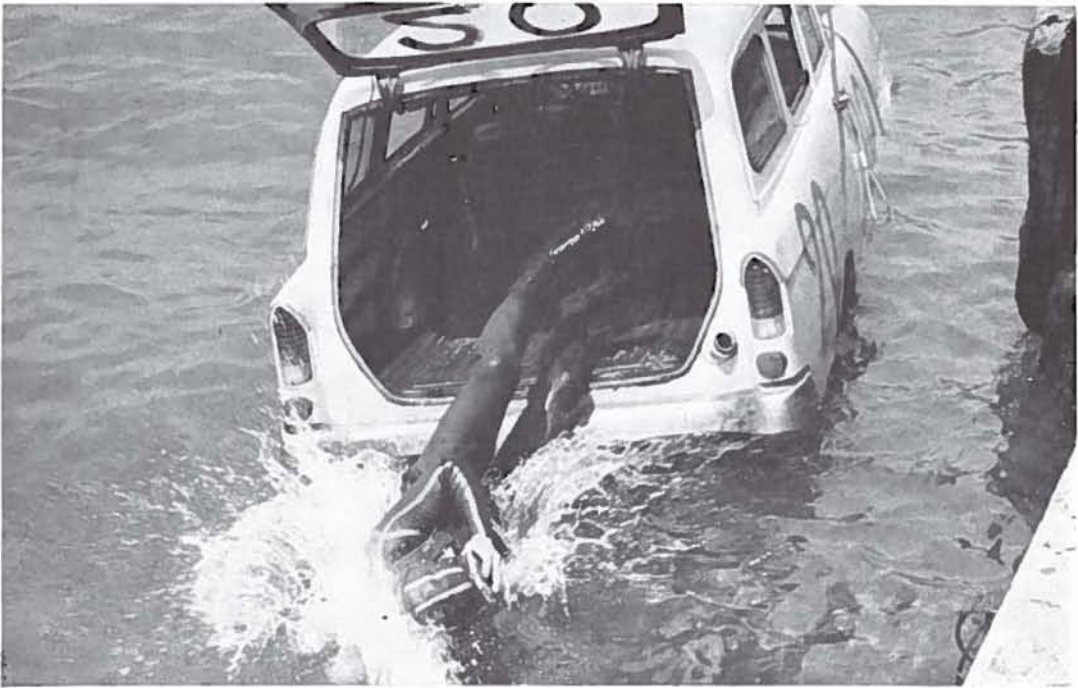
Figure 27. If a tailgate can be opened from the inside, it often proves to be a good escape route.

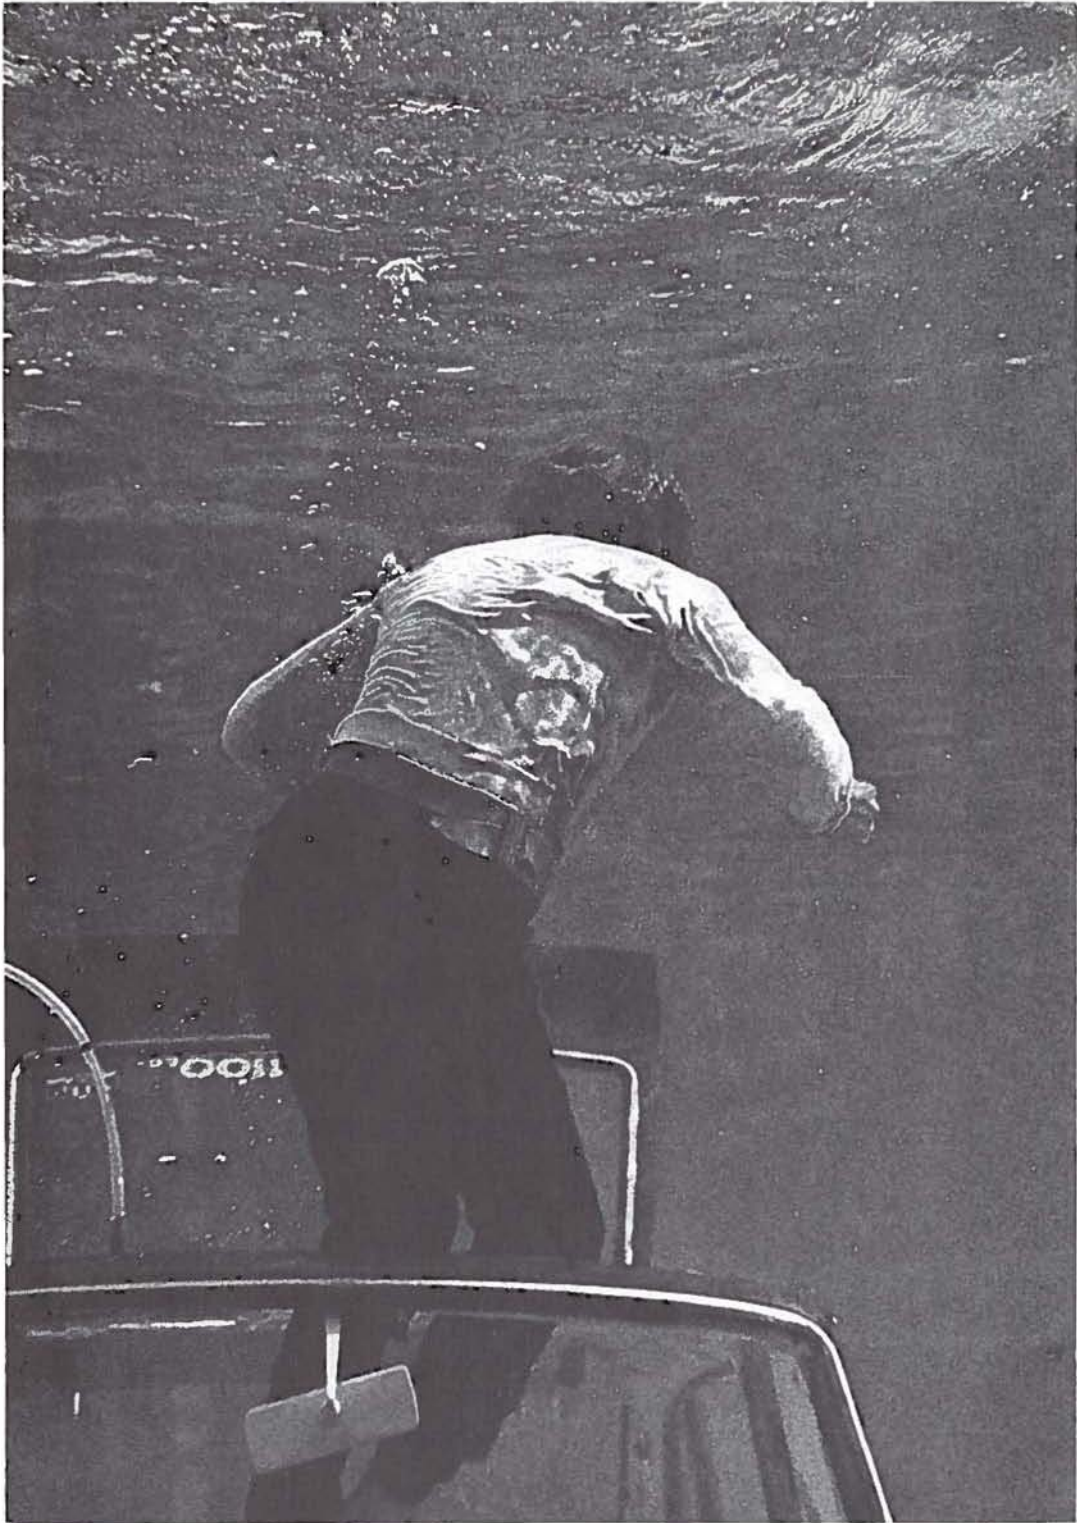
Figure 28. If all the doors are jammed under water or if the vehicle has sunk too deep into the mud, one can easily get out of the submerged vehicle through the open roof.

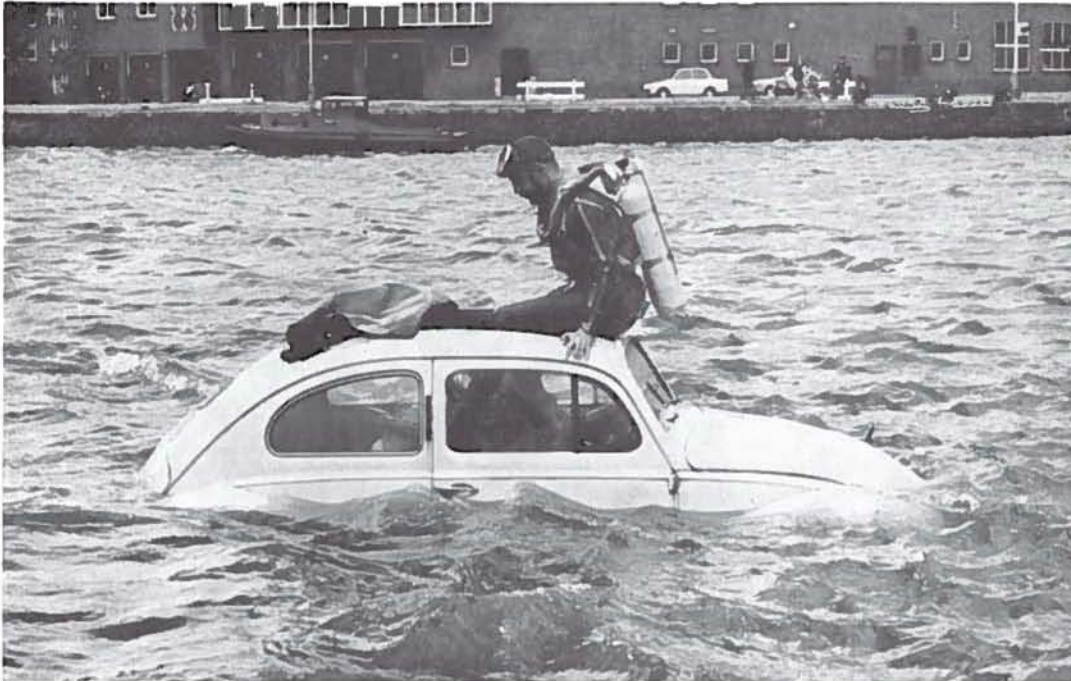
Figure 29. It might even be possible to escape through an open roof without getting wet.

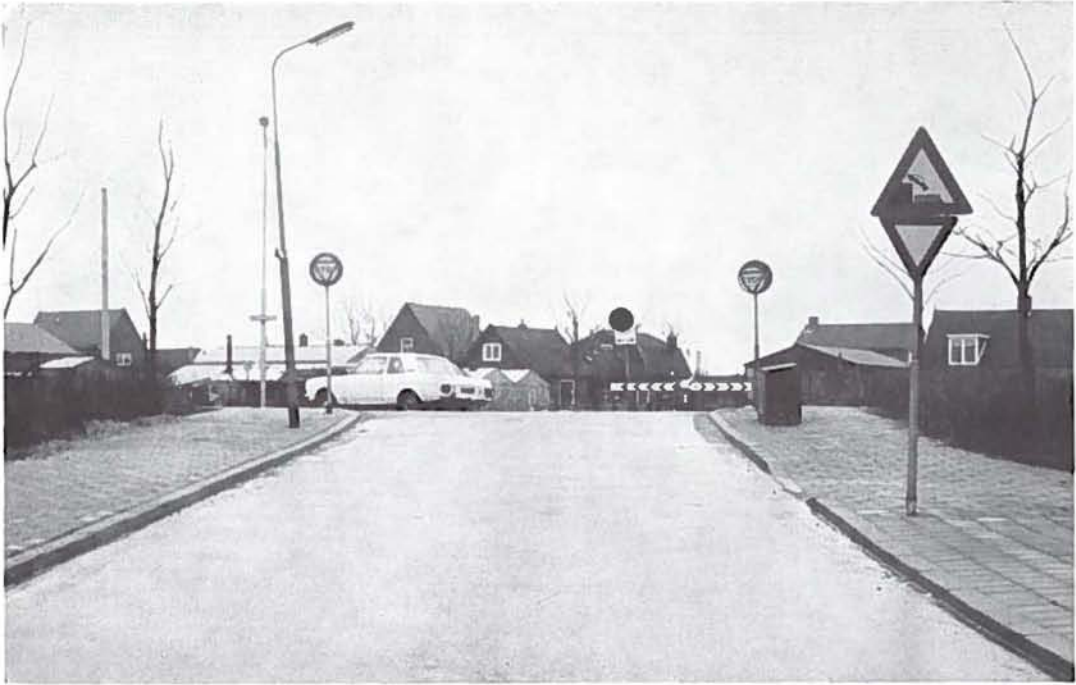
Figure 32. The preventive effect is not high in this instance.

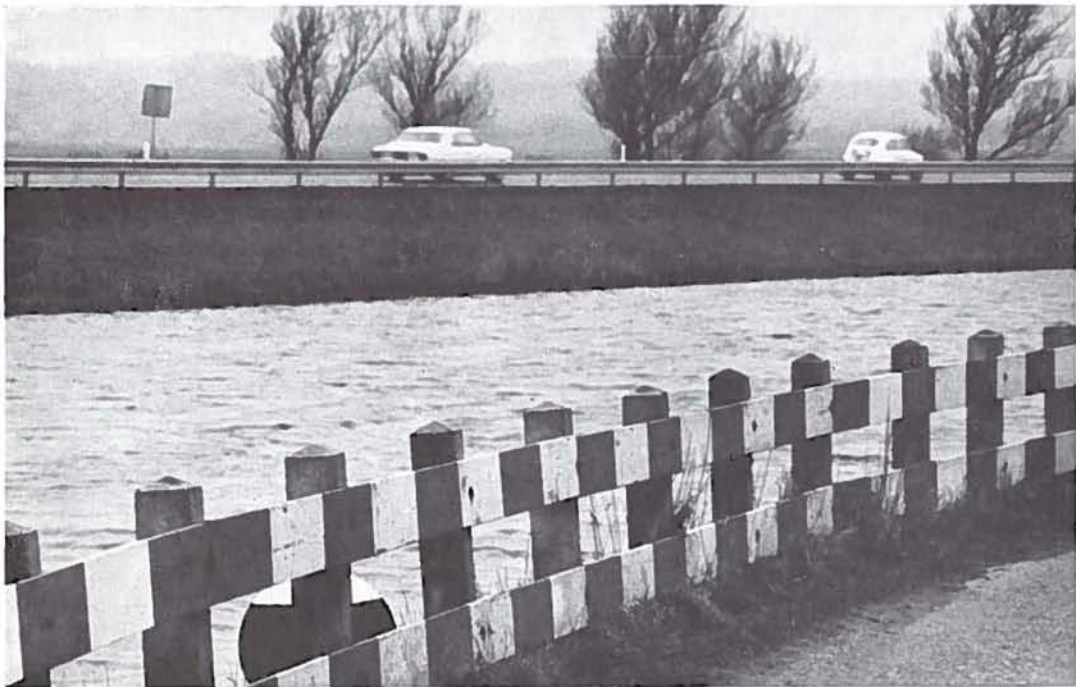
Figure 33. The proper (steel) crash barrier should lead to a drastic reduction in the number of vehicles crashing into the water.
