AFTER SEVEN YEARS RIMOB IN PRACTICE

An evaluation of the Dutch impact attenuator RIMOB

R-90-49

SWOV Institute for Road Safety Research, The Netherlands

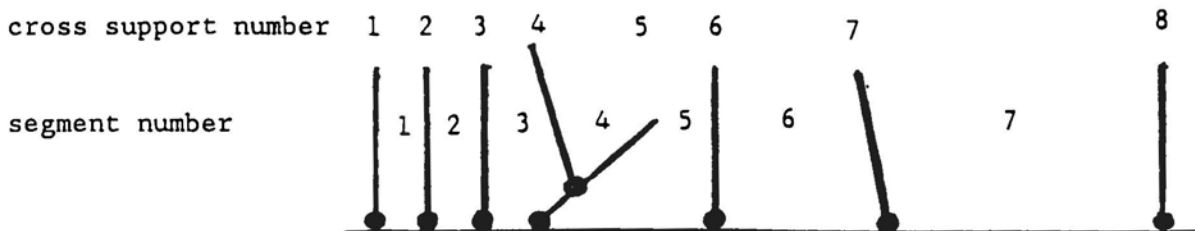
The first three supports stand reasonably upright when RIMOB is completely deformed. The fourth one is pushed up and tilted somewhat backward. The top of the fifth support is tilted forward and is found more or less under the fourth. This picture is valid for the V-270.

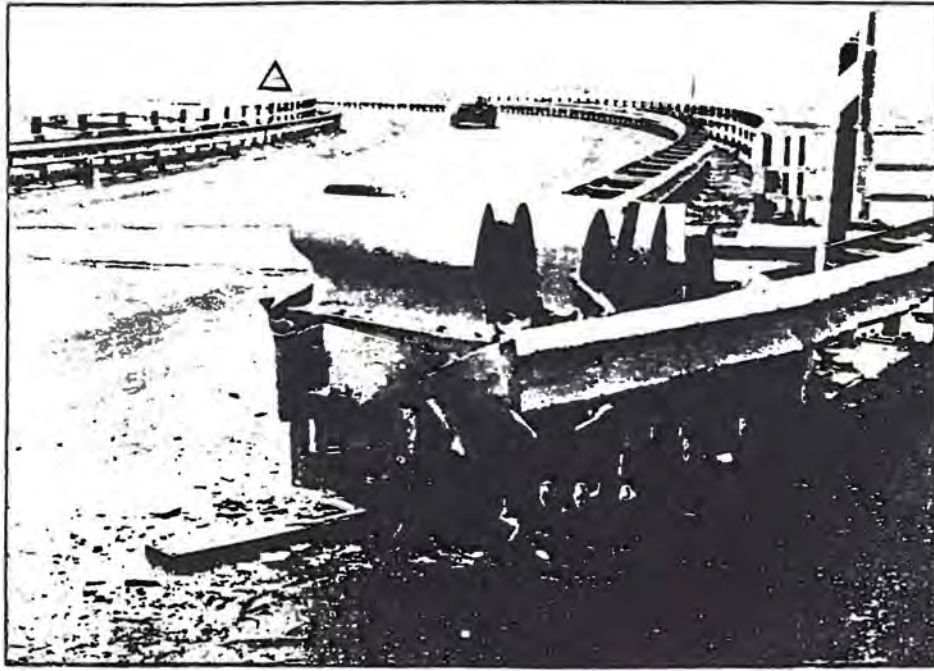
Figure 8. RIMOB after a collision

From 1982 to June 1989 97 RIMOBs have been hit (see Figure 8). This number is fairly well known, because repairs are executed after each collision. As the expenses are always charged to the driver or to the Guarantee Fund the registration is accurately kept up to date by the road authorities.

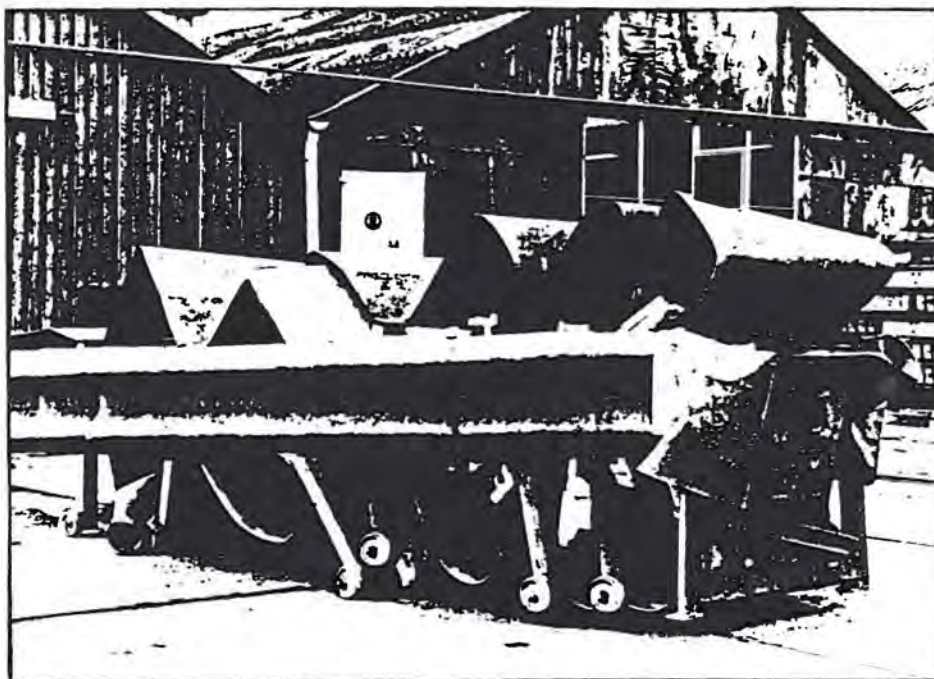
Figure 9. RIMOB after demounting; Inclination of the cross supports

In a heavy collision the deformation is ideal if the segments are completely compressed and the cross supports between the segments have been pushed backward vertically. On photographs of compressed RIMOBs, however, several cross supports appear to be inclining backward or forward (sometimes even to 45°). This is possible because the connection between cross supports and guide-rail elements exists of easily deformable deformation strips. The following general picture can be drawn of the inclining cross supports with the aid of the photographs of heavily damaged RIMOBs (See also Figure 9).

The V-185 shows the same picture in heavy collisions, but the tilting begins one section earlier.

Because of the inclination of the two mentioned cross supports RIMOB will probably function less effectively only at severe accidents. One segment absorbs less energy, which causes the buffer segment to be earlier hit.

As this segment is not easily deformed the vehicle deceleration will increase. An other aspect of the inclination regards costs: more damage is done to RIMOB, on the one hand because RIMOB is more compressed, on the other hand by more torsion and bending. It is recommended to provide all segments with spacers, except the buffer segment.

The deformation in the longitudinal direction is to be called satisfactory apart from some minor criticisms. Often the segments are deformed successively in the right way. Because of the inclination of the cross supports, the application of spacers in all segments is recommended, except for the buffer segment.
