# lighting columns

*Research on the behaviour of lighting columns in sideways-on and head-on impact tests with private cars*

INSTITUTE FOR ROAD SAFETY RESEARCH SWOV

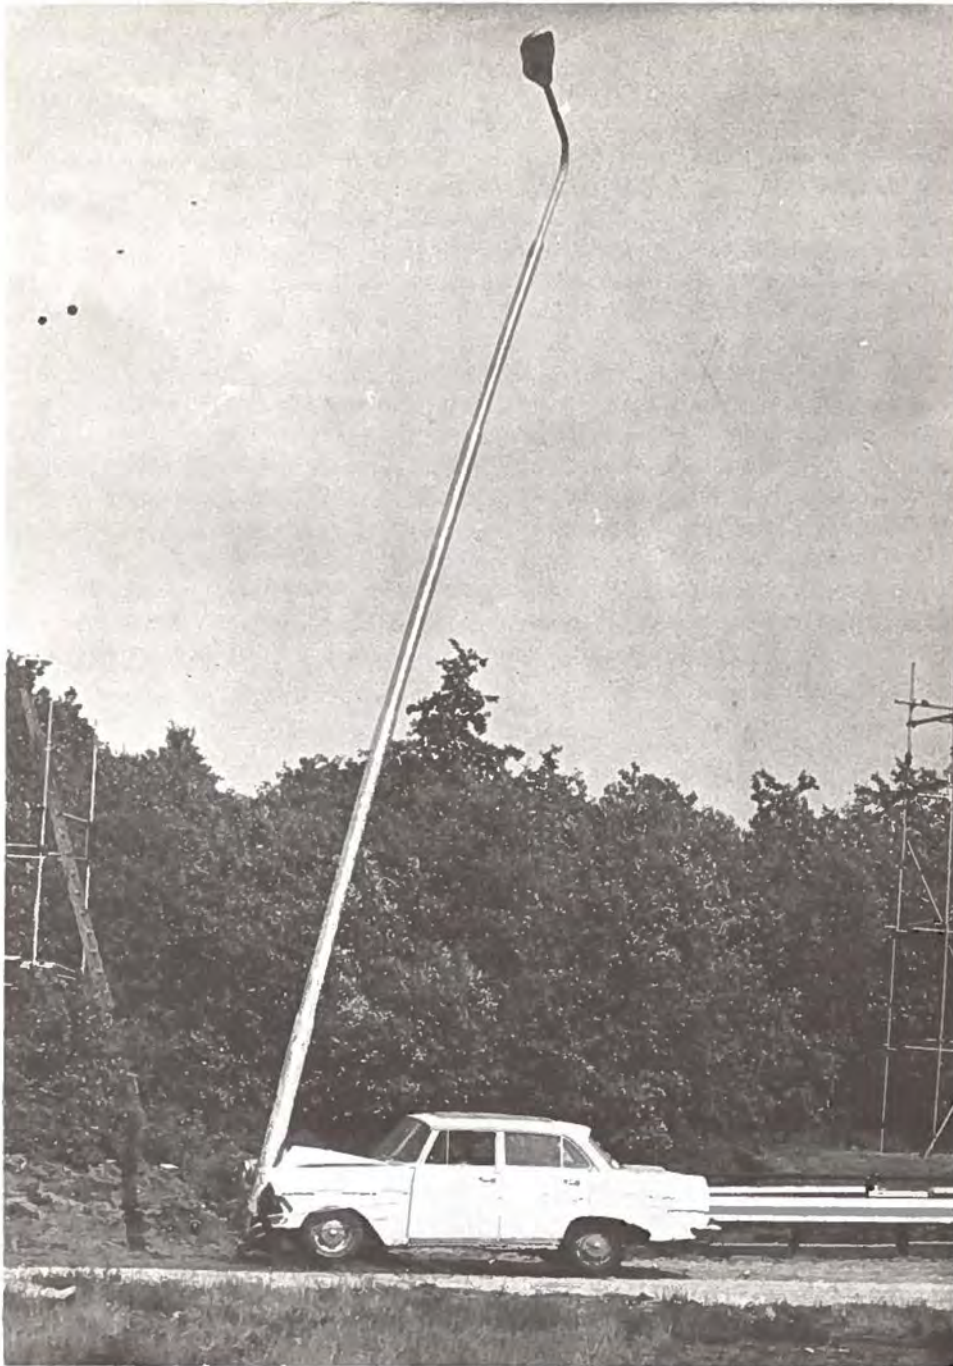
**Figure 6.** *This 12 m aluminium column was hit head-on in test series A tests at 70 km/h. It broke at the bottom of the door opening. The root section did not break but was flattened near the cable opening.*

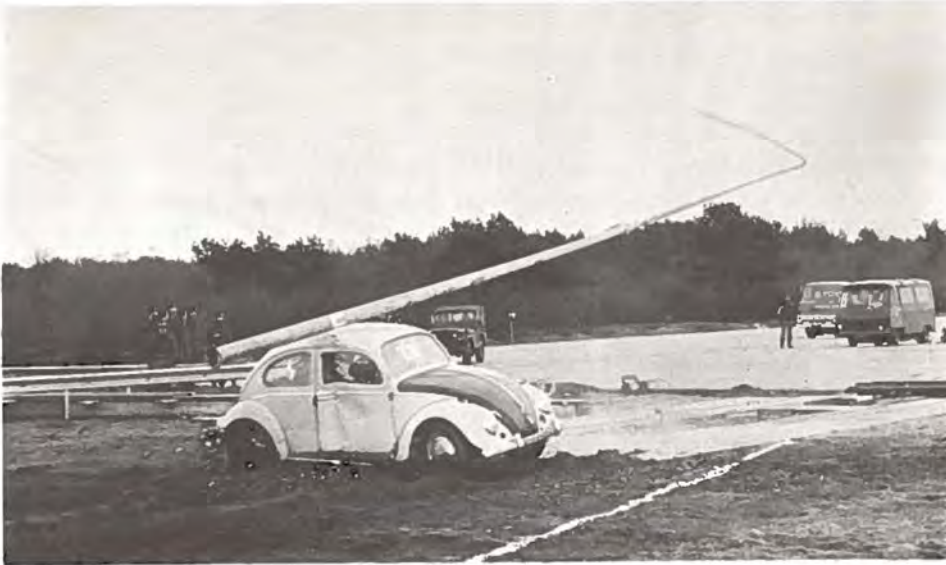
**Figure 7.** *This 10 m slip-design steel column hit laterally in test series B at 42 km/h, gave low vehicle decelerations. It fell on the car's roof; both sideways and roof dents remained within the maxima.*

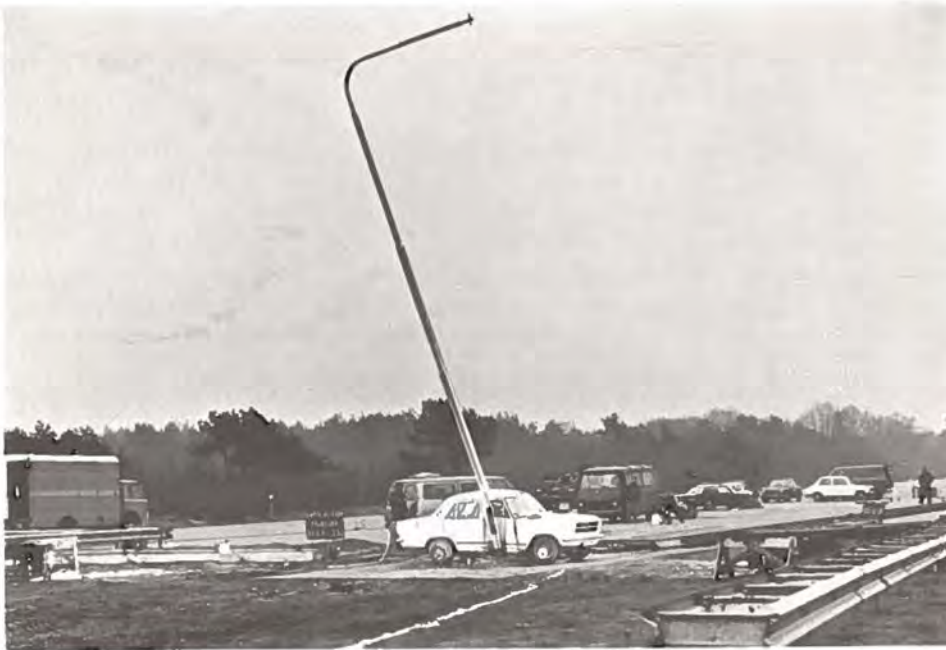
**Figure 8.** *This 10 m aluminium column hit sideways-on in test series C at 30 km/h gave acceptable vehicle decelerations. But it did not break; the vehicle came to a stop against it. The dent in the vehicle's flank exceeded the maximum.*

In four sideways-on impact tests in which the calculated ASI's without seatbelts were less than unity, the sideways dent in the vehicle at the height of the front door exceeded the 15 cm maximum adopted. This was found in two cases of steel columns with a slip design in which the excess was 3 cm (L11 and L14) and in two cases of aluminium columns in which the excess was 11 and 8 cm (L32 and L42 respectively). These figures are on the high side. One factor was that the bodies of the test vehicles were not all sound. This has considerable influence on the size of the dent, especially in a sideways-on impact.

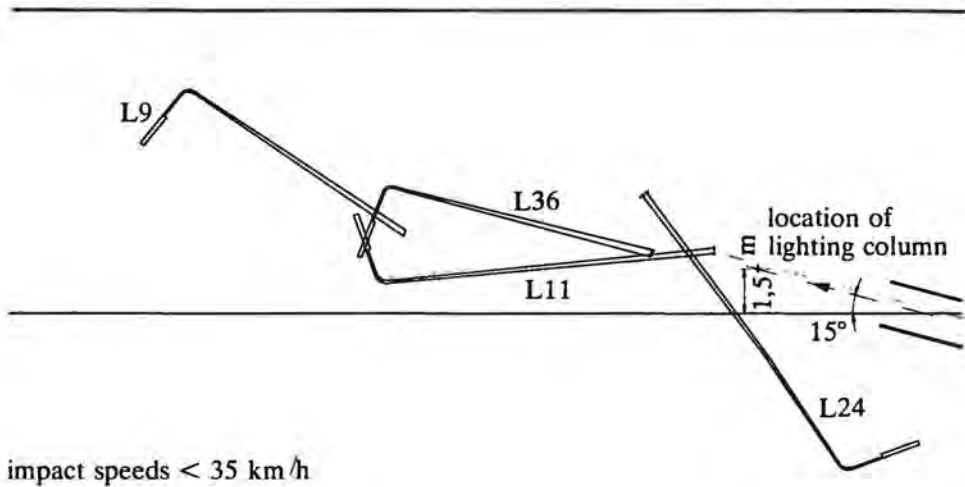
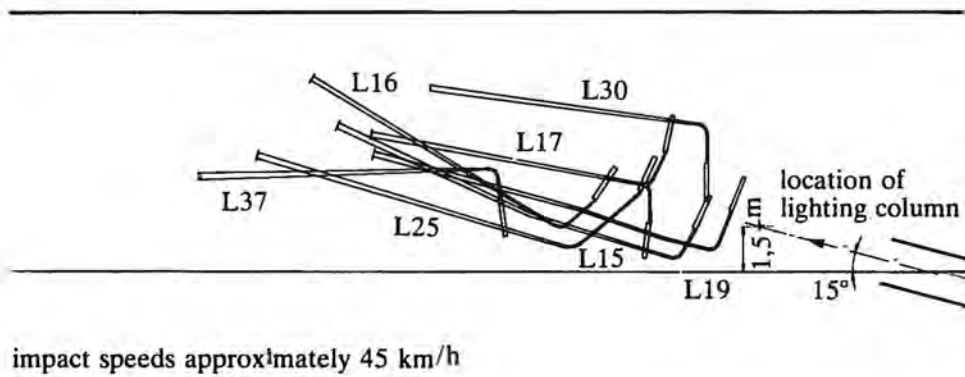
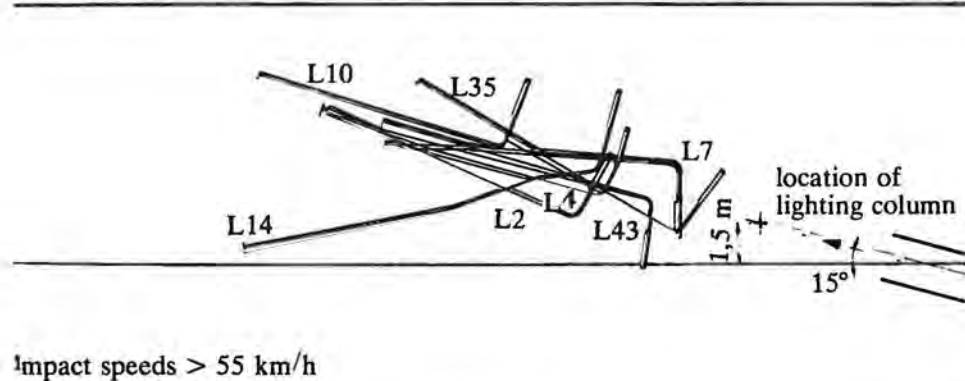
Figure 9 is a good indication for judging whether a lighting column would or would not have fallen on the carriageway. A division has been made into three speed categories: <35, approximately 45 and >55 km/h. All cases of low-aggressive columns (with which the ASI without seatbelts is <1) are included together with several columns for which the ASI was slightly over 1. The columns in test series A which satisfied these criteria are also included, but under the adapted conditions. It should be noted that these are columns that did not carry a lantern of the required weight.

Figure 9- The position of low-aggressive columns after impact by categories: up to 35 km/h, approximately 45 km/h and over 55 km/h.

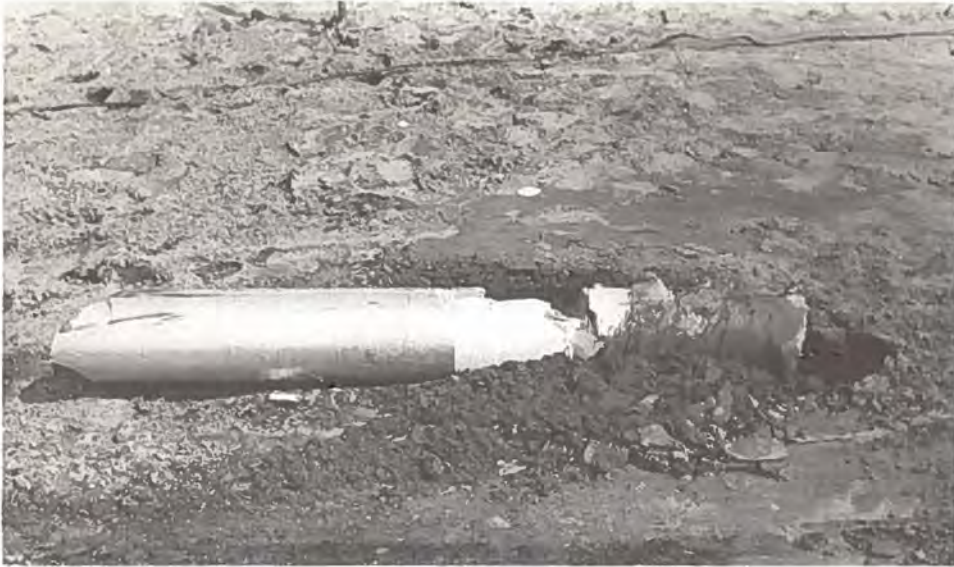
**Figure 10.** *In head-on tests with 10 m aluminium columns not filled with sand the columns broke off at the bottom of the door opening; the root sections were torn about 30 cm out of the ground and broke entirely or partly at the level of the cable opening.*

In series A, *head-on* tests with 10 m aluminium columns *not filled with sand* (L2, L7, L9 and L10), the columns broke at the bottom of the door opening and the root sections were pulled about 30 cm out of the ground by the tensile forces resulting from the bending of the column. Owing to the subsequent bending and shear forces, the root sections broke off completely at the cable opening at higher speeds and broke about three-quarters at lower speeds. In the latter cases the root section folded over 90° and the vehicle drove right over it.

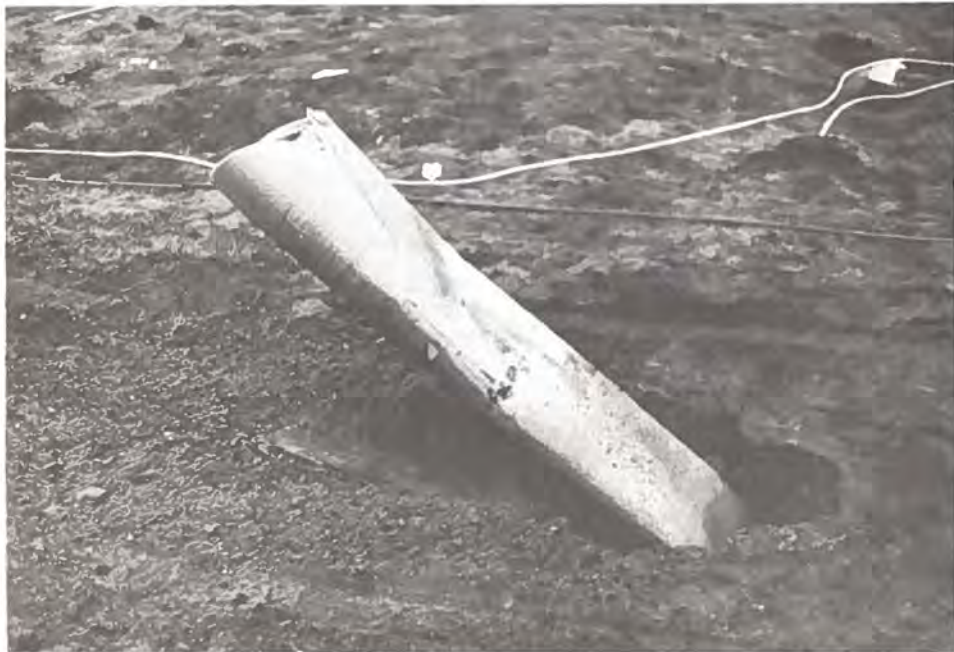
**Figure 11.** *In tests with sand-filled columns the column also broke off at the level of the door opening. The root section however was pulled only slightly out of the ground; it did not break off but folded over at ground level.*

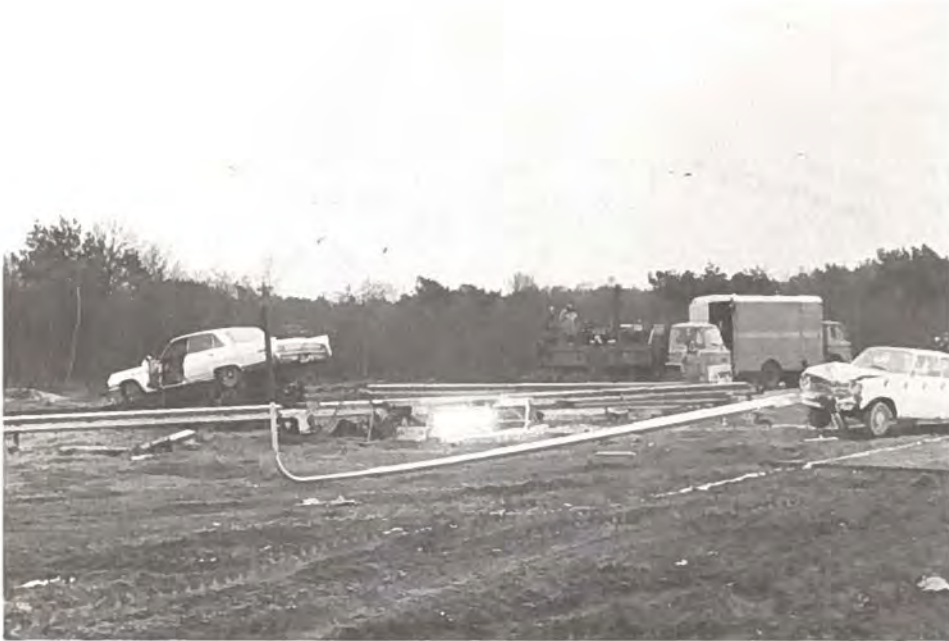
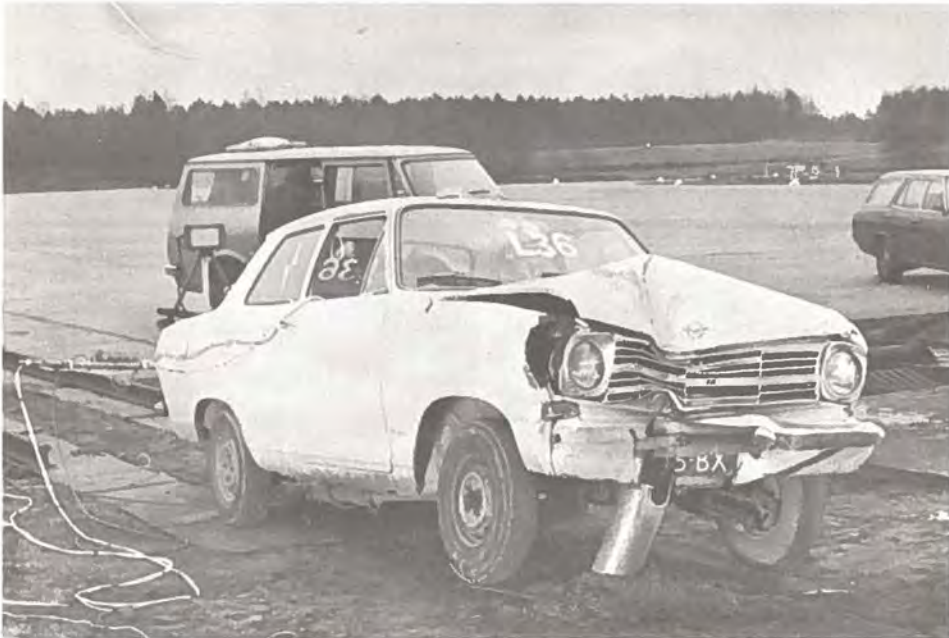
**Figure 13.** In head-on tests with 10 m aluminium sand filled columns, the root section was only bent over at the height of the cable opening so that the bottom of the column stood upright at an angle. Because of the low impact speed, the vehicle came to a stop against the stump.
