Safety Effectiveness and Operating Performance of a Three-Cable Median Barrier on Interstate 5 in Oregon

Christopher M. Monsere, Brett Sposito, Samuel Johnston

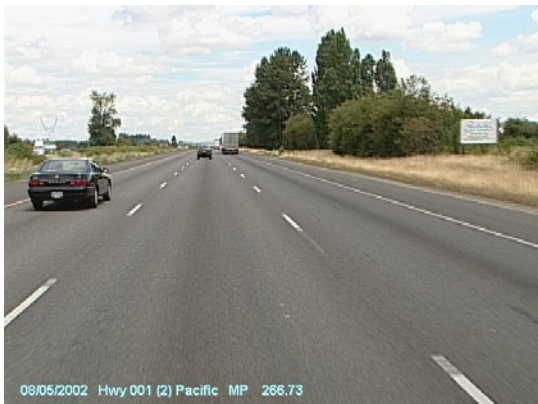
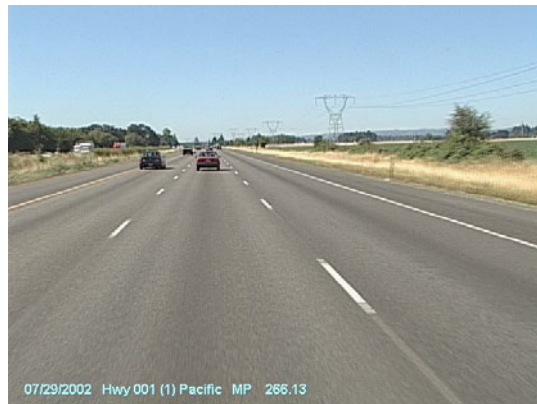
Figure 1 - Video Log Images of Treated Sections

The cross section of I-5 treated with the cable median barrier has three 3.6 meter (12 ft) lanes in each direction. The treated section has an average median width from the edge of pavement to edge of pavement of 15.2 m (50 ft.) and has relatively wide inside paved shoulder at an average of 3.1 m (10 ft.). Milled shoulder rumble strips were installed on both the left and right shoulders in the fall of 1998. The median is grass-covered and rose bushes have been planted to act as a glare-guard. These rose bushes generally alternate from one side of the median to the other approximately every 0.5 mile. The posted speed limit is 65 mph. Volume data was obtained from the state's database. Over the analysis period, the ADT has increased from 66,000 to 82,600 vehicles per day. The volume trends are presented in Figure 5 and 6. The section has a high percentage of Portland to Salem commuter traffic and is one of the more traveled sections in the state. Images from the state's digital video log are shown in Figure 1.

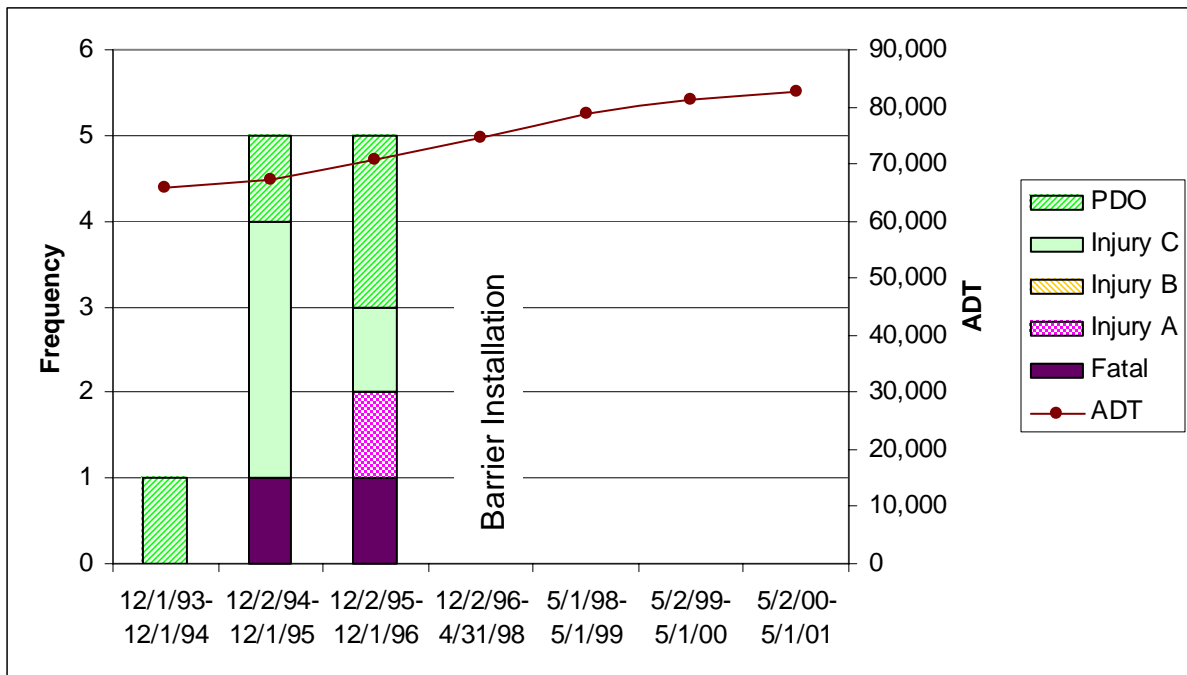
Figure 5 - Reported Cross Median Crashes

In the three year period prior to the installation of the cable barrier, there were 11 crashes (2 fatal and 1 injury A) crashes as a result of a vehicle crossing the median. The remaining crashes were minor injury B or C or property damage. In the three years after the barrier treatment, there has not been a reported crash involving a vehicle crossing over the median. This trend is shown in Figure 5

The data in Figure 5 indicate that the cable median barrier has been effective at reducing cross-median collisions. In the reported database, there has not been one collision in which a vehicle has crossed the median. The review of maintenance records of damage to the cable barrier also supports this observation. From the maintenance records, we estimate approximately 45% of the road departures that could have resulted in a cross median event were stopped by the cable barrier. However, the maintenance and Oregon State Police logs indicate that the barrier

was not totally effective in reducing potential crossovers as there were 5 vehicle under-rides of the cable system and 2 complete penetrations. The penetrations involved larger vehicles, which the barrier was not designed to restrain. The penetrations are not included in the graphed data in Figures 5 and 6, since both occurred during the transition period. In addition, shoulder rumble strips were installed at nearly the same time as the barrier, which also may have had an effect on the reduction in cross-median crashes. Other studies have shown rumble strips effective in the range of 15 to 70 percent reducing run-off-the road crashes (12). Nonetheless, the reduction in cross median crashes is notable given the limitations discussed in the first part of this section.
