AFTER SEVEN YEARS RIMOB IN PRACTICE

An evaluation of the Dutch impact attenuator RIMOB

R-90-49

SWOV Institute for Road Safety Research, The Netherlands

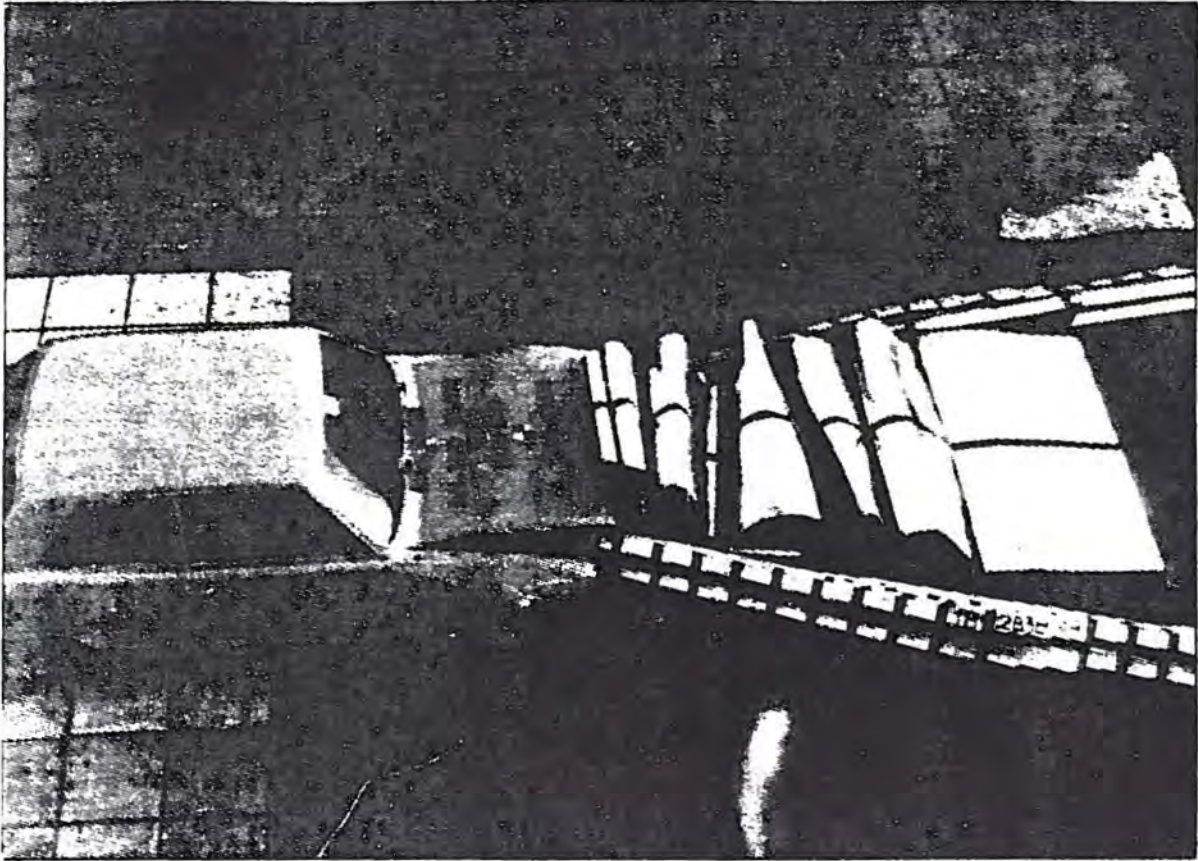
Figure 5. RIMOB after a collision test (100 km/h)

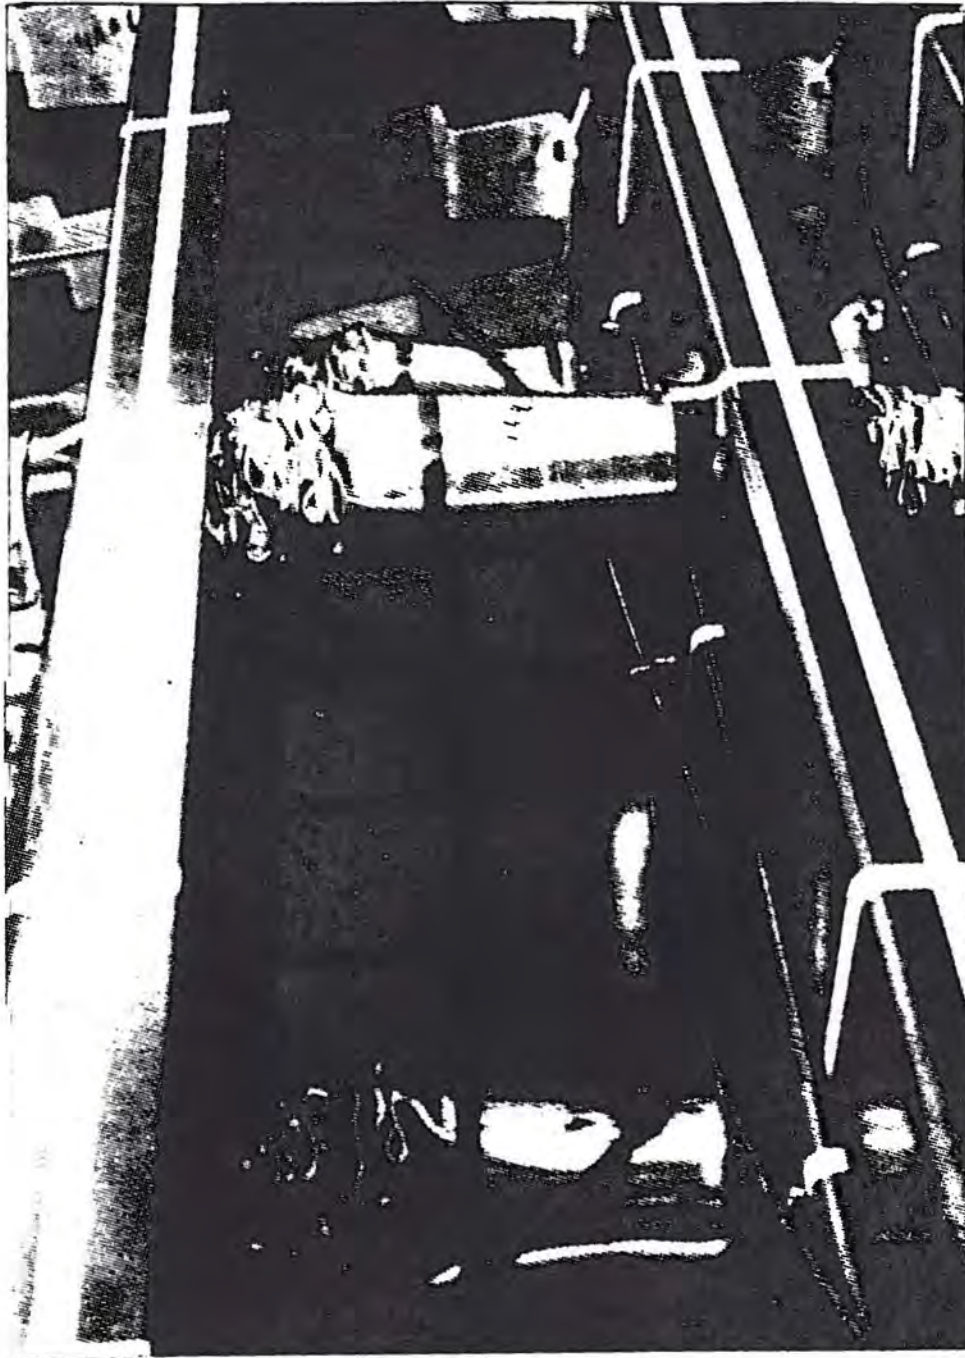
Figure 6. In case of an axial load the crumpling tubes are compressed (RIMOB in the development stage)

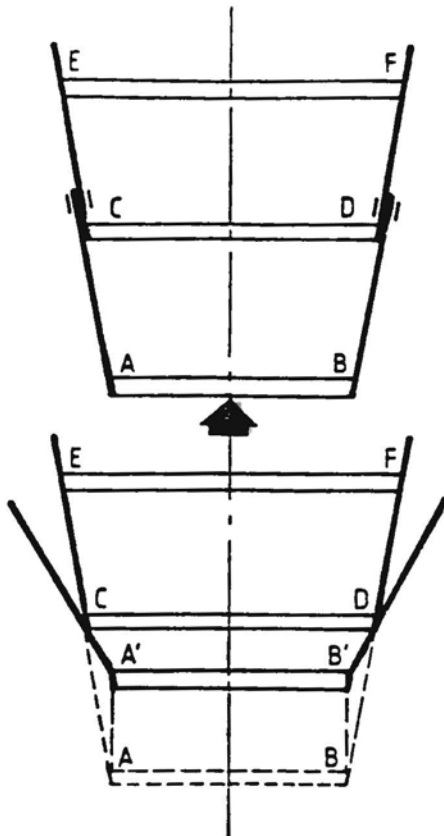
WITHOUT DEFORMATION STRIPS

When AB is subjected to a load, it goes to A'B. C D are fixed points. The AC and BD side rails are forced to bend outwards. As a result, the railguards are broken.

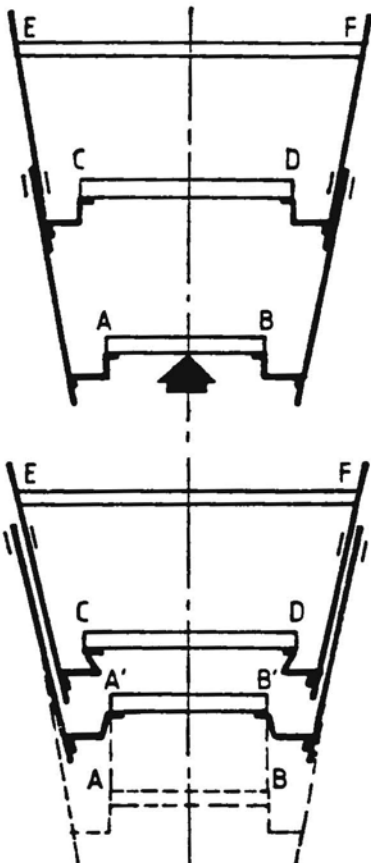
WITH DEFORMATION STRIPS

The connection between A,B,C, and D and the sides is effected by means of deformation strips. When AB is subjected to a load, the C and D deformation strips bend inwards and the A and B strips outwards. In this way, the side rails remain parallel, with the help of the railguards which has been attached.
